Inspection Report

Mine Name: Roundabush 1

Permit number: M0450027

Inspection Date: 04/03/08

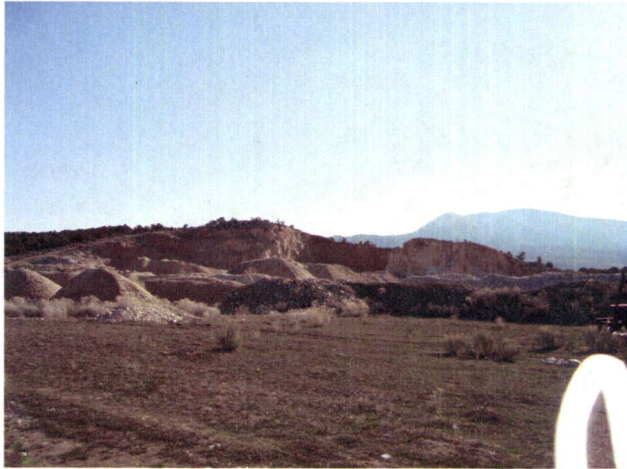
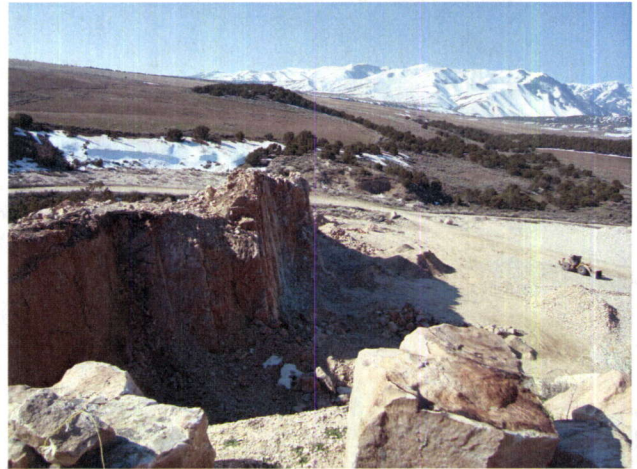
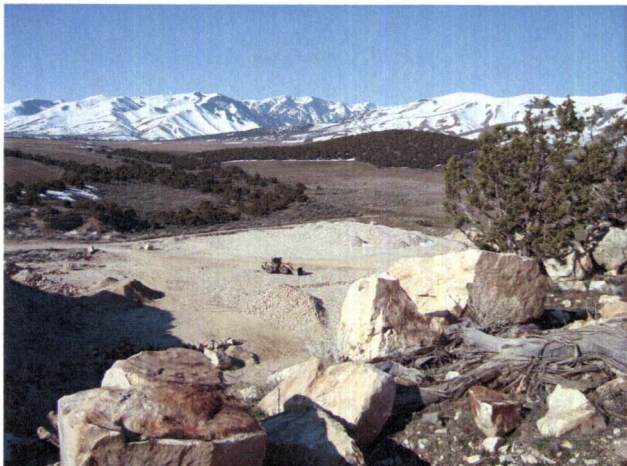
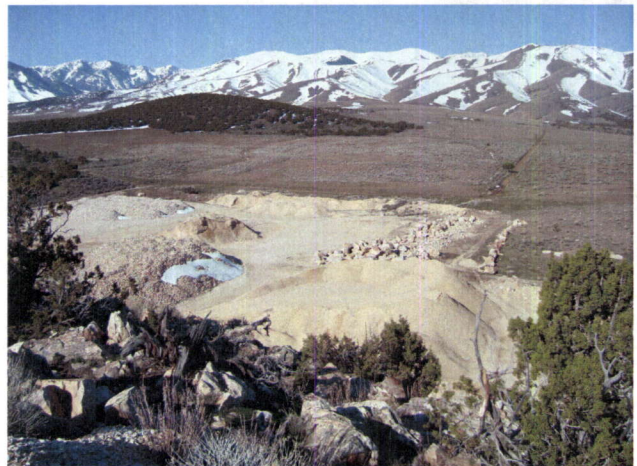
Photos taken 04-03-08

Inspection Summary: Mine overall was in good shape. No deleterious material was found. Roads were in good condition, but mine was not active at the time of the site visit and it is not known if a water truck was used during hauling for dust control. A small loader was on site. Numerous stockpiles have been processed, but still on site. Topsoil stockpile had vegetation growth. Note photos are attached.

Conclusions and Recommendations: Operator should review the Mine site for public safety issues and highwall safety. Future inspection visit is to include detailed GPS survey.
